US Army Corps of Engineers

HURRICANE KATE STORM SURGE DATA

Report 5

Coastal Engineering Research Center

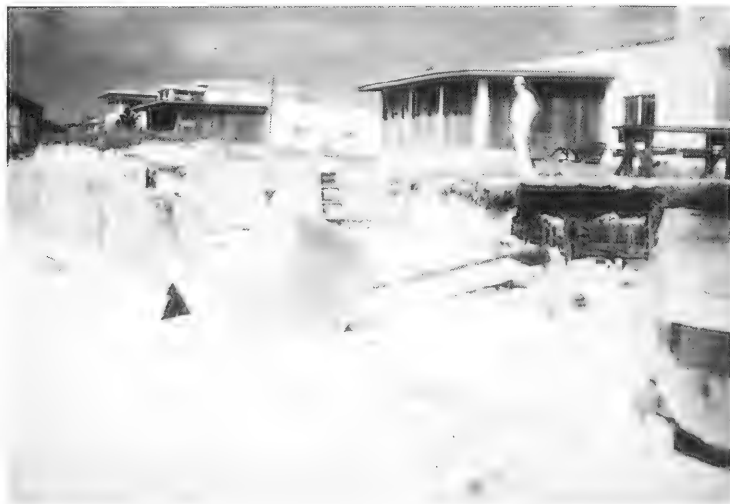
14. At Mexico Beach, the erosion was more severe, uncovering and destroying a seawall (Photo 2) that had been completely buried by a sand dune prior to the hurricane. Surge elevations estimated at this location from the watermark on the side of the canal on the west end of town (Photo 3) were approximately 7 ft. Wind damage in this area was relatively minor.

Photo 2. Destroyed seawall, Mexico Beach, Fla.

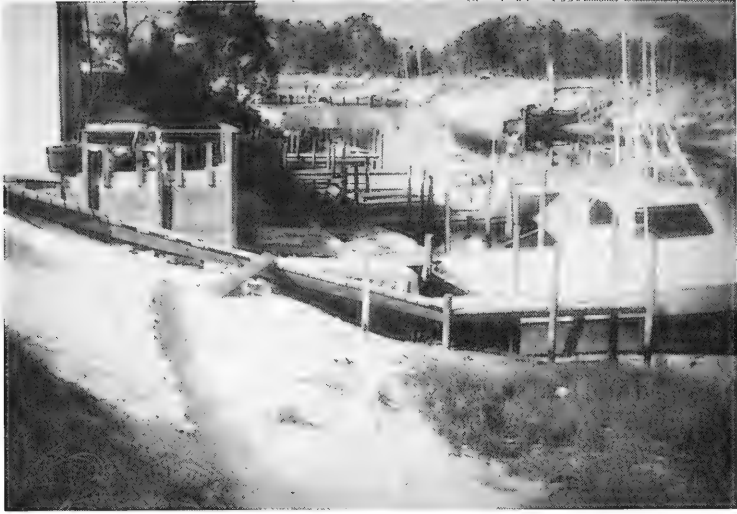
Photo 3. High-water mark, Mexico Beach, Fla.
